Manhole Inspection Summary

Manhole # S3700_044MH

Insp Date: **1/30/07 8:09 AM**

Location Address: **735 22ND ST**

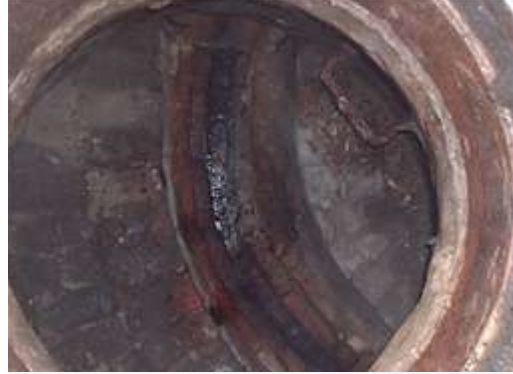
Top View

Corroded and missing steps. Evidence of surcharge - Bench debris.

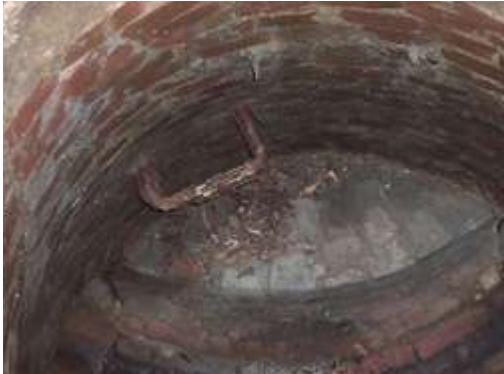
Defect

Frame leaks. Adjustment and Barrel infiltration.

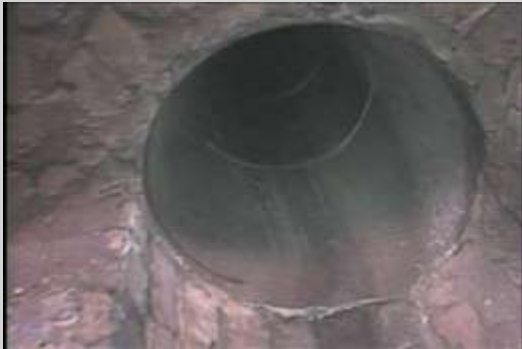
15 in. Circular Gravity Sewer Pipe Out @ 12 O'Clock

Infiltration: **Evidence** Pipe Seal Cond: **Unknown**

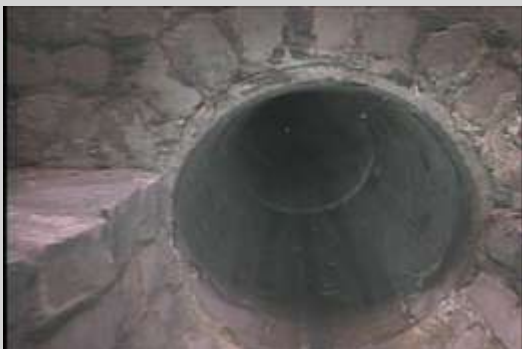
15 in. Circular Gravity Sewer Pipe In @ 4 O'Clock

Infiltration: **Evidence** Pipe Seal Cond: **Unknown**
